Bureau of Mines Information Circular/1986

Evaluation of Safety Shutoff Valve System on Methane Gas Pipelines Under Mine Fire Conditions

Information Circular 9065

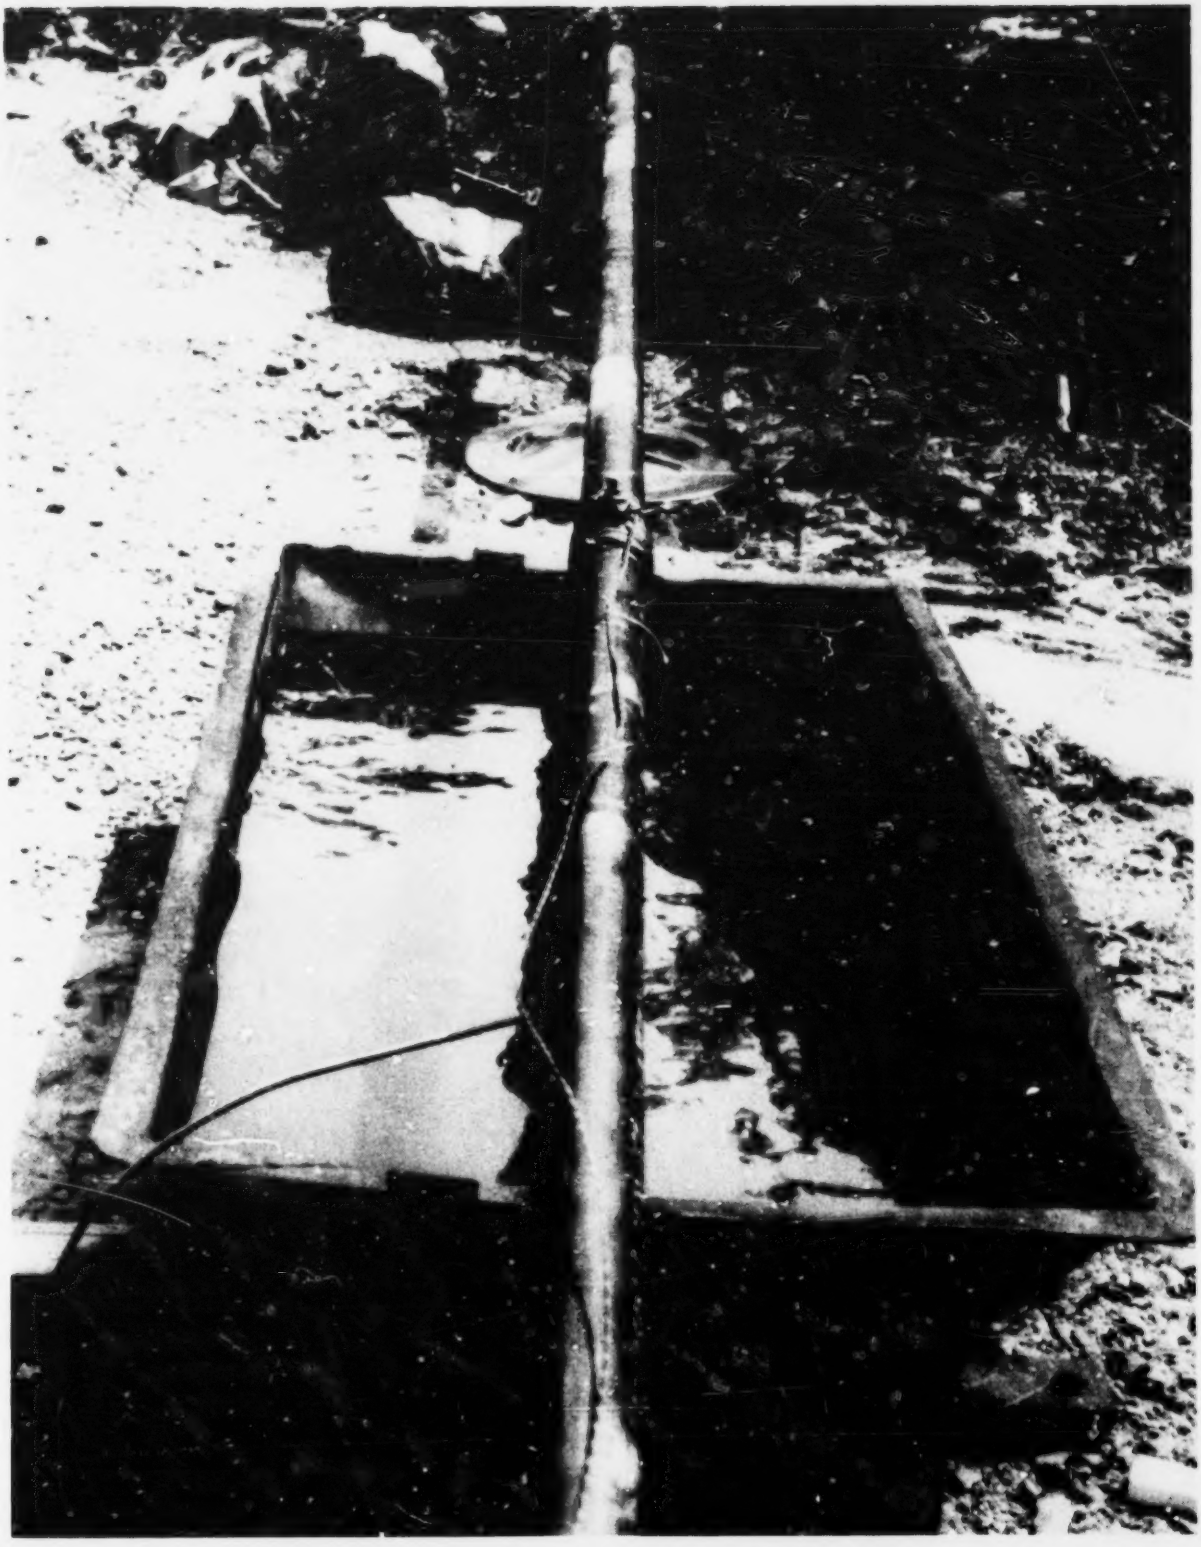
Field tests were conducted at the Bureau's Lake Lynn Laboratory. A series of pan fire tests was performed on the ball valves, using kerosene as the bulk fuel and heptane as the starter fuel. The test set up consisted of two 10-ft sections of 2-in-diam, standard, schedule 40 steel pipe connected to either end of the ball valve. The ends of the pipe were supported, so that the valve was suspended over the fire pan (fig. 1). One pipe section was sealed and pressurized with nitrogen gas. The nitrogen gas leakage rate was monitored with a pressure gauge and a flow meter. Three thermocouples were used to monitor the temperature of the fire, the outside valve body temperature, and the internal temperature of the valve body around the Teflon seat (fig. 2). The pressure gauge, flow meter, and elapsed time were continuously monitored with a video camera. Thermocouple temperatures were monitored using strip chart recorders and a microprocessor.

FIGURE 1. - Test setup for temperature durability evaluations.

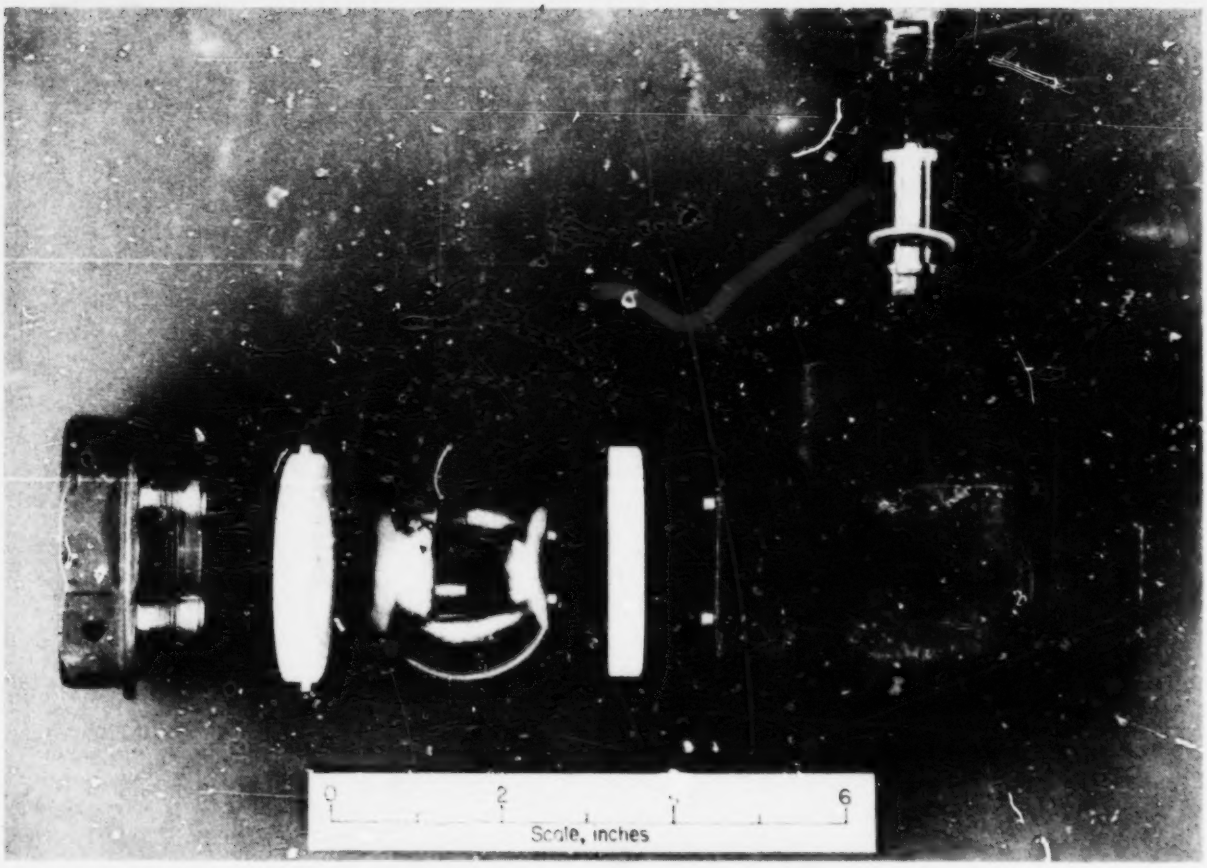
Two ball valves were initially tested without an actuator or any thermal protection: a fire-safe valve and the brass valve currently used by the Bureau. The fire-safe ball valve was constructed of stainless steel with a Teflon seat and an asbestos stem seal. The Bureau valve has a brass body with a Teflon seat and a Teflon stem seal; its cost is about one-fourth that of the fire-safe valve.

FIGURE 2. - Components of brass valve.

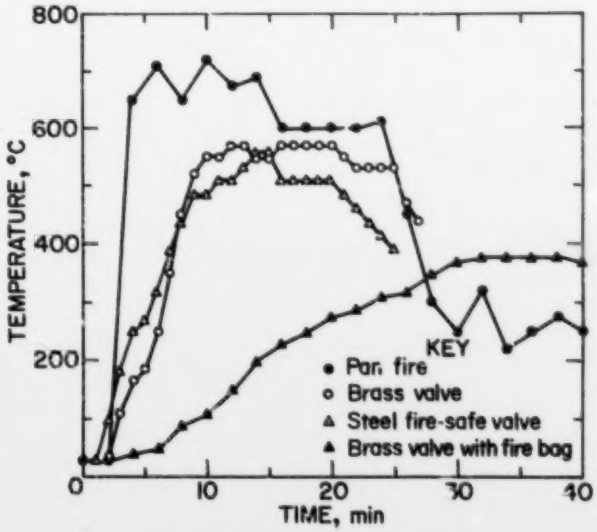
Initially, in each test, a pan fire using 15 gal of kerosene was ignited under the unprotected valve, producing temperatures of 500° to 700° C over a 30-min period. Both valves recorded an internal temperature of 500° to 550° C on the seats at 11 min (fig. 3); this is the temperature range in which Teflon polymer begins decomposing extensively. Not surprisingly, for tests with both valves the flow meter began rising after approximately 11 min, indicating a leak in the system through the valve.

FIGURE 3. - Results of fire test.

Once the shutoff valve system was constructed, the valve was wrapped in the "fire bag." Twenty gallons of kerosene was used for these tests to extend the life of the fire from 30 min to 40 min. The kerosene was ignited, and after 20 s the PVC pipe burst, confirming its effectiveness as a fire warning mechanism. As a result, air pressure on the actuator was released, causing the valve to close and stopping the flow of nitrogen gas. After 40 min of fire exposure at temperatures between 500° and 700° C, the ball valve seat and stem seal were still intact and maintaining line pressure. The internal temperature on the Teflon seat was only 380° C at the end of the 40-min period (fig. 3), as compared with 550° C after 11 min without the "fire bag" (fig. 3).

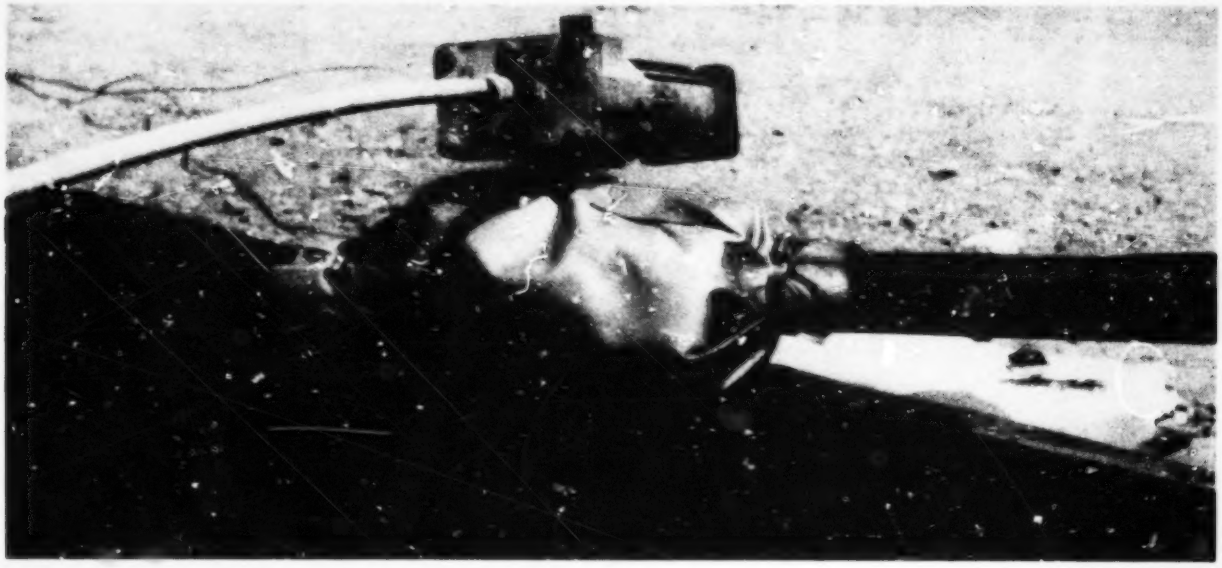
FIGURE 4. - Closeup of a brass valve protected with a "fire bag."

A complete shutoff valve system was constructed for the "fire bag" tests. An air actuator was attached to the normally closed brass valve, and 60 psig of air was applied to the actuator through 1/2-in PVC pipe to keep the valve open (fig. 4). The initial reason that PVC pipe was chosen to carry air to the actuators was that it is inexpensive and would break easily if there were a roof fall on the pipeline (1). Line pressure would drop once the pipe was broken, causing all valves in the system to move to the closed position and thus halting methane gas flow. Given the fact that the PVC pipe being used had a low melting point, it could also serve as a fire warning mechanism. The same series of shutoff events would occur once the PVC pipe burned through as when the pipe was broken by a roof fall.

The results of the investigation indicate that the ball valves now used in the Bureau's methane drainage pipeline system can be retrofitted with an inexpensive "fire bag" to substantially increase the system's short-term integrity under mine fire conditions. It was also established that the more expensive fire-safe ball valves are no more effective at sealing a low-pressure gas line under high-temperature conditions than a thermally unprotected brass ball valve.
